# CTIS Leak Repair

## Gilbert Herman

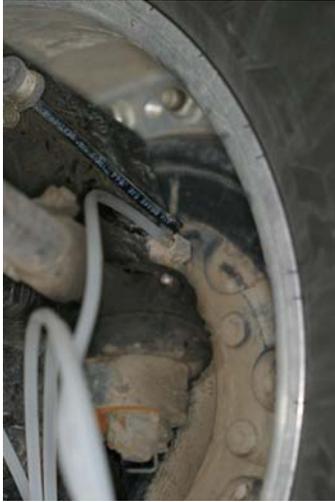
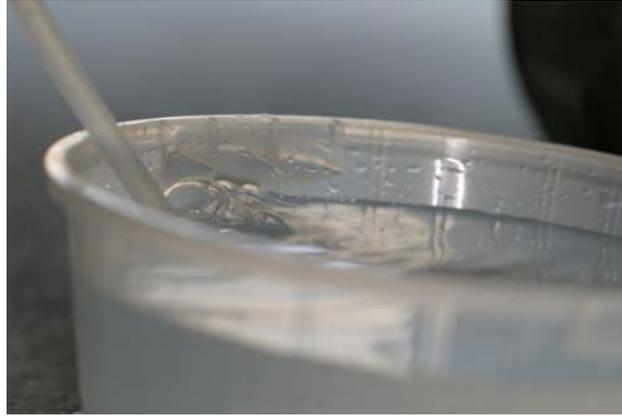
Figure 1 (Left) shows the test hose attached to the vent on the geared hub. (Right) the end of the hose is placed under water.

You can see active bubbling due to a spindle seal leak.

If in your diagnostic workup item #3 occurred and the vent leak test was positive, you need to replace the spindle seal. Disengage the CTIS from both wheels. Some people have replaced this seal with the tie rod (front hubs) or stabilizer (rear hubs) still connected by swinging the cover away from its mating hub surface. I find it easier to do this job at the bench. To remove the tie rod or stabilizer, remove the cotter key from the castle nut and then the castle nut itself (1 1/16 inch socket) while the truck weight is still on the suspension system. Now jack up the truck, place on a jackstand, chock the wheels, disconnect the CTIS valve from the hub (7/8 inch) and remove the tire. Remove the airline to the rear of the hub. There is a swivel joint on this line. The 5/8-inch side is fixed to the braided line with the 13/16-inch side the portion that rotates.

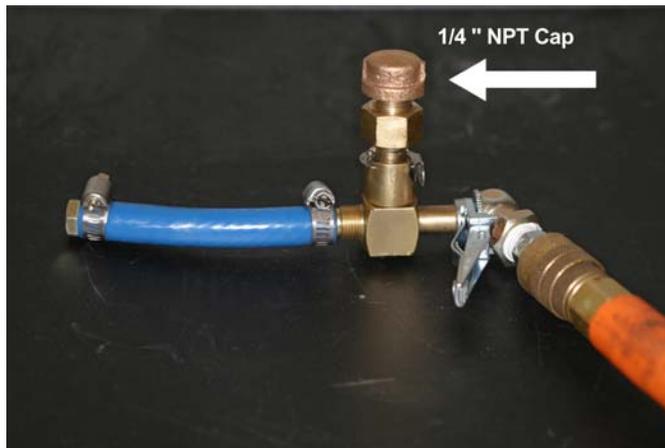
Figure 1 (Left) This is the system that I use for valve testing.

Due to the awkward position of the CTIS valve when attached to the rim, it is difficult to fully test for leaks. I recommend removing the valve and bench testing it if the leak is not obvious. When you remove the valve, insert a standard 1/4 inch NPT tank valve into the rim to prevent the tire from fully deflating. Separate the CTIS valve from the small plastic hose. Attach a 1/4 inch NPT end cap on the threaded portion that attaches to the rim, sealed tubing to the valve portion that attaches to the plastic tube. Attach an

airline going to a compressor set for 40 PSI. Immerse this CTIS unit into a bowl of water observing for leaks. Test the valve in the engaged and disengaged positions.

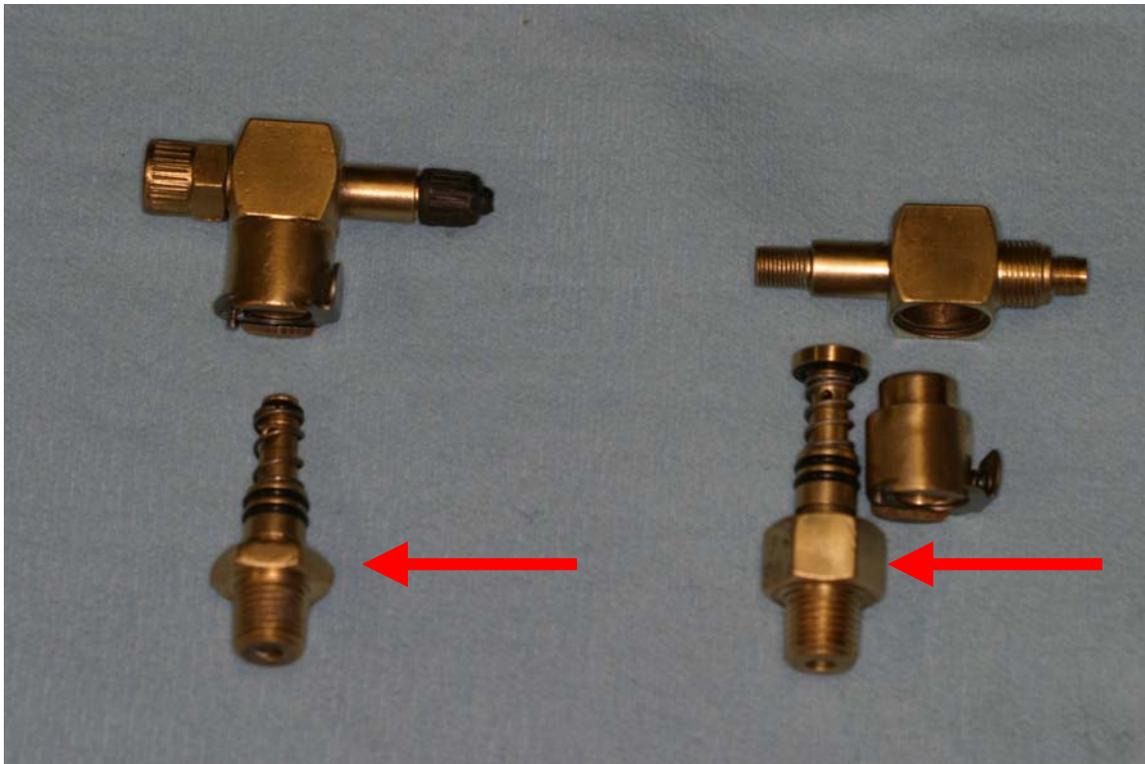
The old style valve has two components that form the body, whereas the newer valve has three. You can identify the valve model by examining the hexagonal nut portion that threads into the spindle. The brass nut on the old style is  $\frac{1}{4}$  inch thick (0.205 inch) with the newer style  $\frac{1}{2}$  inch thick (0.500 inch). The identification is critical in determining how you will approach the disassembly.

Figure 2 (Above) The old style valve is left, new style right.

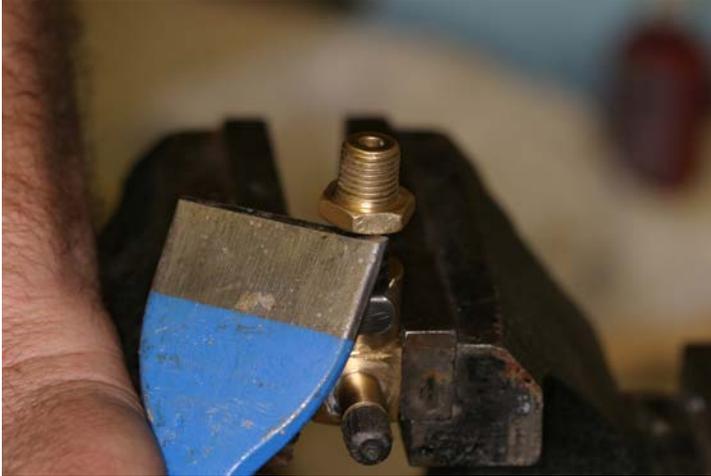
Figure 3 (Left) Placement of the chisel for old style valves.

To disassemble the old style valve, place the main body in a vise securely. Using wood stirring sticks between the brass valve and the vise jaws will protect it from scratches. Place a chisel on the hexagonal nut and using a plastic mallet hit the chisel with moderate force. Rotate the hexagonal nut 180 degrees and repeat procedure until the stem separates from the base.

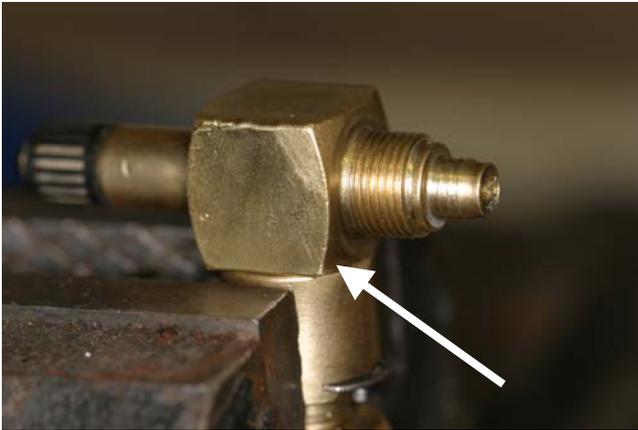
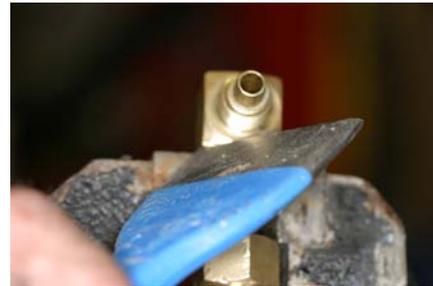
Figure 4 (Left) Location for placement of the chisel on new style valves. (Right) Chisel in position.

To disassemble the newer style valves, the chisel is placed where the square portion of the body joins the cylindrical portion.

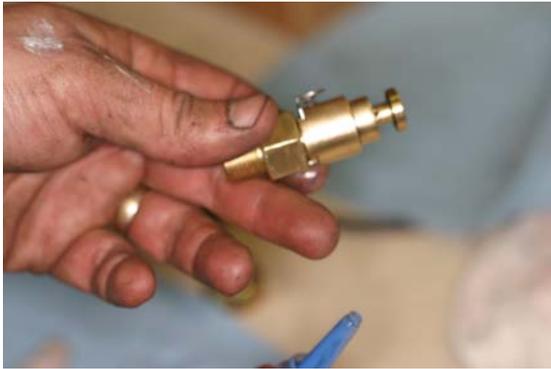
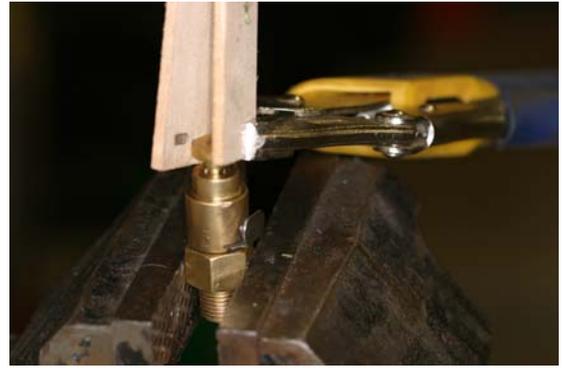
Figure 5 (Left) Cylindrical body housing removed (Right) Removal of brass seating disk

The old style valve DOES NOT have any further disassembly, so omit this step. Once the main valve is separated, removing the brass disc that threads on the shaft of the new style valve further disassembles the mechanism. Holding the main stem portion in a vise, place wood painters sticks on either side of the brass disc, clamp with a Vise-Grip and rotate in a counter-clockwise fashion.

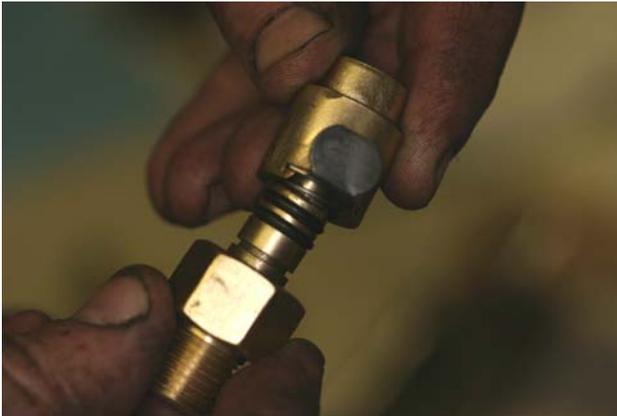
Figure 6 (Left) Press in the tab, separate the two components and remove the spring. This exposes the O-rings on the main shaft that tend to cause valve leaks.

I have only replaced the O-rings on the main shaft that has cured all of my leaking valves so far. I use a Metric P8 Nitrile O-ring having a diameter of 11.56 mm, thickness of 1.62 mm. There is an O-ring on the sealing surface of the brass disc, an O-ring inside the short barrel that houses the silver tab and an O-ring that seals the cylindrical portion to the square portion of the housing. These are cleaned with isopropyl alcohol or acetone. All external surfaces of the brass fixtures can be buffed with a Dremmel having a wire wheel. Clean the tab and the adjacent brass surface with both the tab pushed (in) and (out). To release the tab, push in the little silver spring-pin.

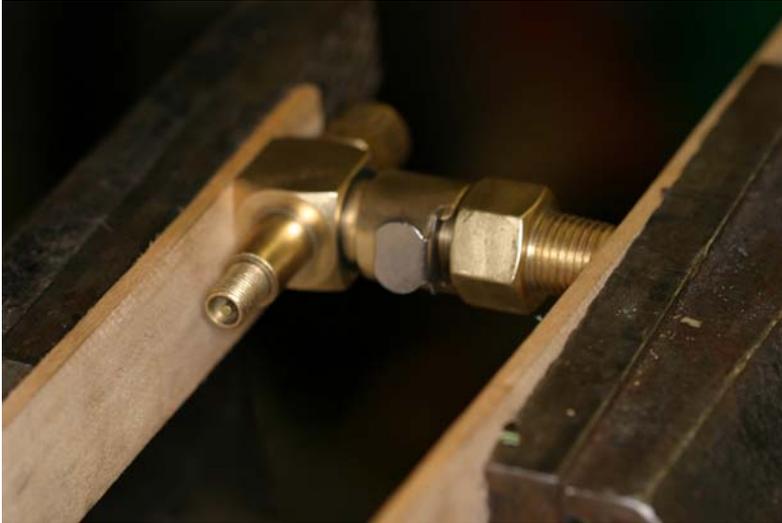
Figure 7 Using a vise to press in the valve body components.

Reassembly is the reversal of this procedure. To complete the assembly, orient the tab to the valve stem correctly, insert the cylindrical body portion into the square body portion confirming that the o-ring seal is present and either compress the halves in a vise (protecting the thread surfaces with wood) or use a plastic mallet to drive them together.

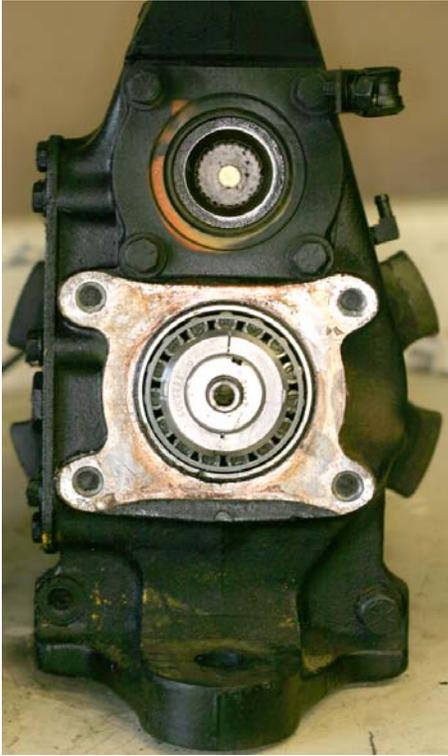
Figure 8 (Left) The Hub with the control arm plate removed. This exposes the clamp nut that holds the spindle. Above this is the exposed halfshaft input seal.

Move the hub so you have good access to the four bolts (20mm socket) that attach the steering control arm to the hub. Remove these bolts. There are two thick spacers that go beneath the protective covers of the airline and four flat washers. Remove the cover. Gear lube will leak out at this point so place a catch basin below the hub. All of the internal components must be protected from debris for these are machined surfaces. With the cover removed, you now have access to the spindle clamp nut.

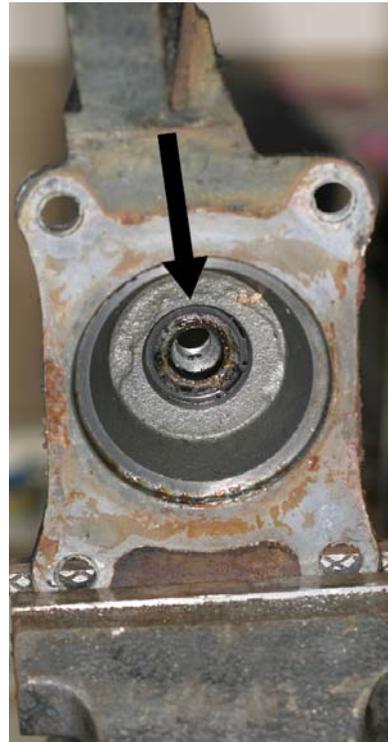
Figure 9 (Right) This photograph demonstrates the spindle seal with the snap-ring in place.

I prefer to take the control arm plate to the bench for the seal removal and installation. I just find it easier to properly seat the seal on a flat stable surface. At the bench, remove the internal snap ring using small tipped snap-ring pliers.

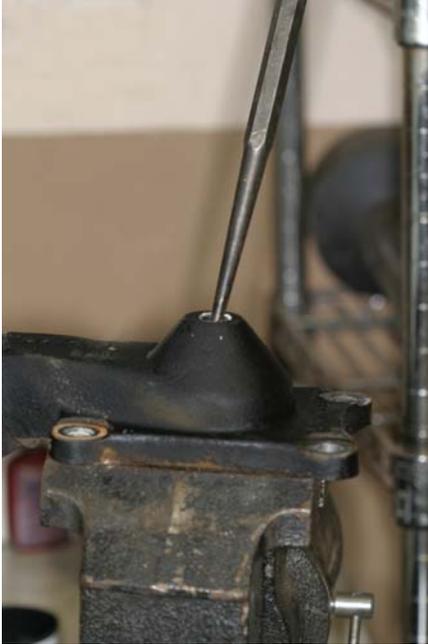
Figure 10 (Above) Using a long punch, catch the edge of the seal and hit the punch briskly with a hammer to unseat it.

To remove the seal, flip the housing over, place a long blunt surface punch through the airline opening and hammer out the seal.

To reassemble, place the new seal into the housing, use a large socket with hammer to drive the seal into place. It is important that the seal is pressed in place .....level. When the seal is below the snap ring notch, it is properly seated. Replace the snap ring. The steering cover and hub must have all old anaerobic sealer removed and a new coating of RTV Silicone applied prior to reassembly. Reassembly is basically a reversal of the above procedure.
