CTIS Electrical Repair
Gil Herman
March 23, 2003

Symptom: No inflate or deflate when properly working just 1-week prior.

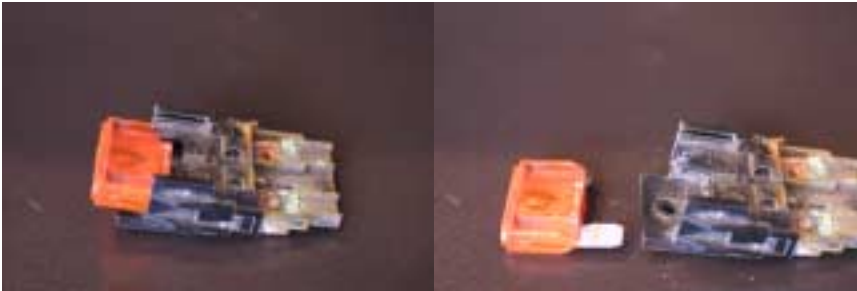
Looks Good

No, It Isn't!

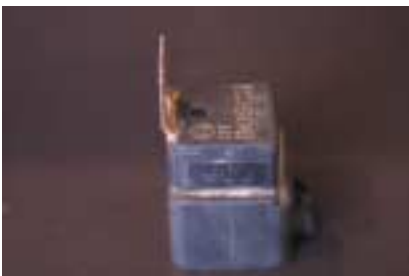
The CTIS Relay

3. Examine 40-amp fuse; be sure to pull it out. If OK, then:
4. Remove relay; jump the lead going to the compressor to the hot lead coming in from the harness. If OK, then: replace the relay. The low voltage circuit is most likely out. You could verify that 12 volts are delivered.

1. Relay is from a 1989 Buick Regatta, Filko RL 246
2. 40 amp fuse and holder was replaced with a 40 amp circuit breaker
3. Deflate solenoid was purchased from AMG for \$265.00 but if you can wait 6 to 8 weeks, they come from Switzerland. Call Kunding Controls in Auburn Hills, MI 248-391-6100. The solenoid is made by Lucifer SA part number: 491514C1 at \$32.50. The connector is made by Canfield Connector, Youngstown, OH, part number: MPC Type-1, P5103-3610000, 6-48 VDC, 249500096. This is: \$6.50.

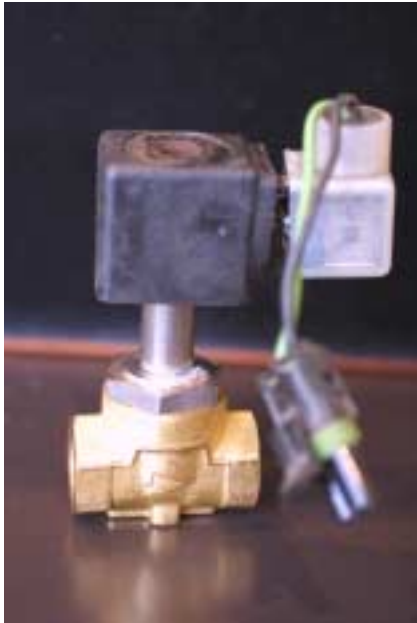
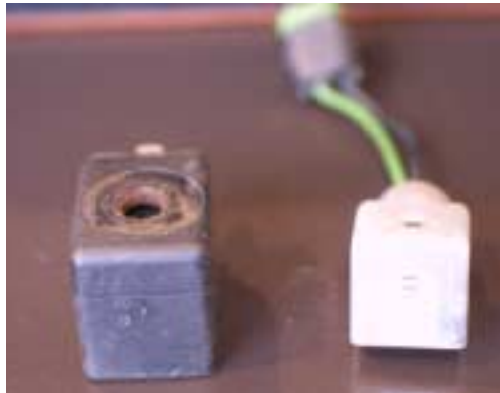
1. The valves have both the electrical component, which energizes the circular coil that resides in the Bakelite solenoid and the air passageway with valve. The electrical component can be removed from the shaft, by removing the retaining nut. In my case, it took a pry bar to pull it up and off. It was frozen to the stem. Once removed the actual valve mechanism can be worked on. I have the early 1996 valve tree so each valve is an individual unit, hooked to each other by connector pipes. With the solenoid removed, you can get a wrench into the tight space and remove the top of the valve housing. Inside there is a bullet shaped plunger with the tapered end seating into the valve housing. It will move up and down the shaft when the electrical coil generates magnetism. By opening the housing, you can clean out debris that mechanically blocks the valve.

2. This is a picture of an old valve, like mine:

7. Upon getting the compressor to work, try the deflate. In my case when I hit the deflate I immediately blew the 1G mini fuse. In my case, I replaced the mini fuse, disconnected the deflate wire harness and placed a multimeter. I then hit the deflate switch and found 12 volts. I then replaced the solenoid to the deflate valve. This fixed my problem.

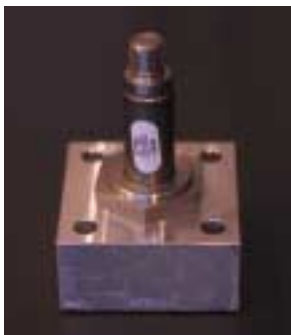
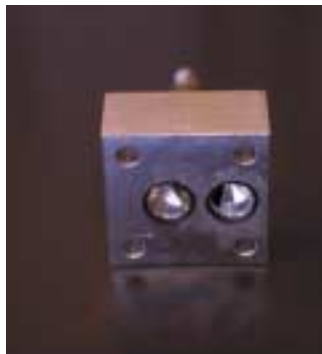
3. This is the newer style valve:

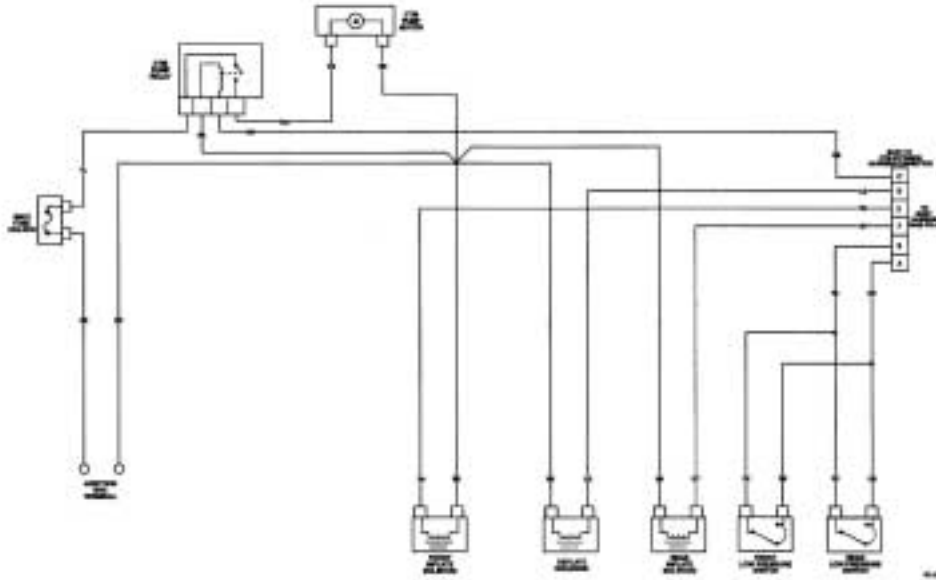
FO-23 (2) (Rev. 1/98)

Electrical Schematics for the CTIS System:
